TRAFFIC BRIDGE CAPACITY CHECK AND FENDER DESIGN

Design and Navigation Assessment

BG&E
Fremantle, Perth
Western Australia
Australia
2013

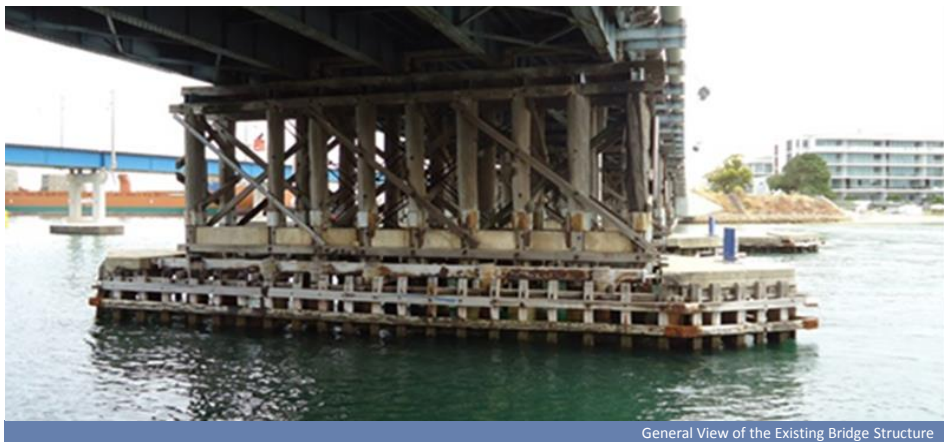
General View of the Existing Bridge Structure

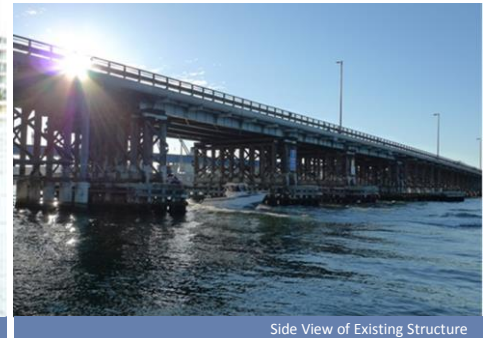
Side View of Existing Structure

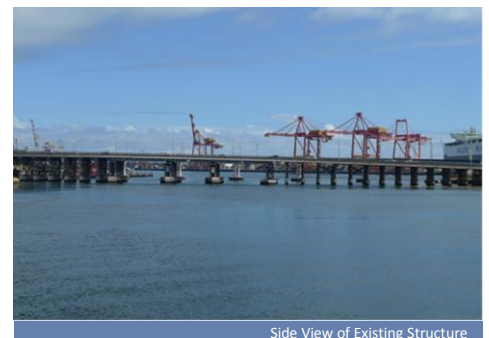
Side View of Existing Structure

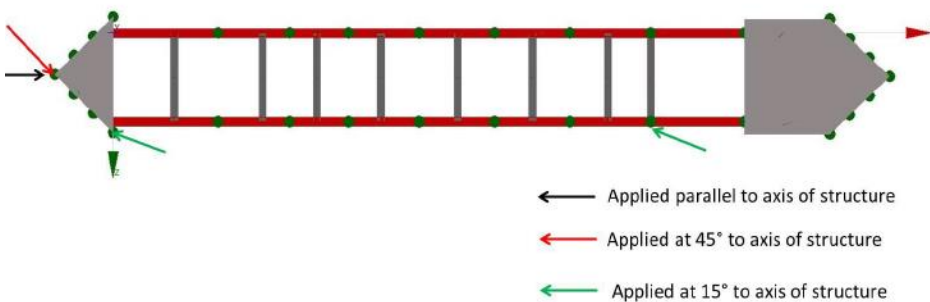
Structural Modelling in Prokon

PRDW determined the capacity of the bridge fender system to withstand a range of vessel impact scenarios. Deliverables included a series of graphs presenting the maximum allowable impact velocity relative to vessel displacement for different accidental and operational cases. These graphs would be used in the subsequent design of the rehabilitation of the structure.

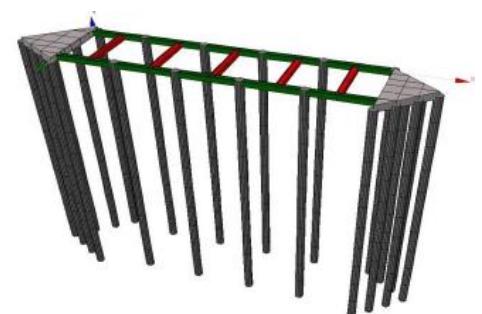
Structural Modelling in Prokon
